2025 - NOTICE TO SHIPPING # 1

NIAGARA REGION WELLAND CANAL

General Instructions

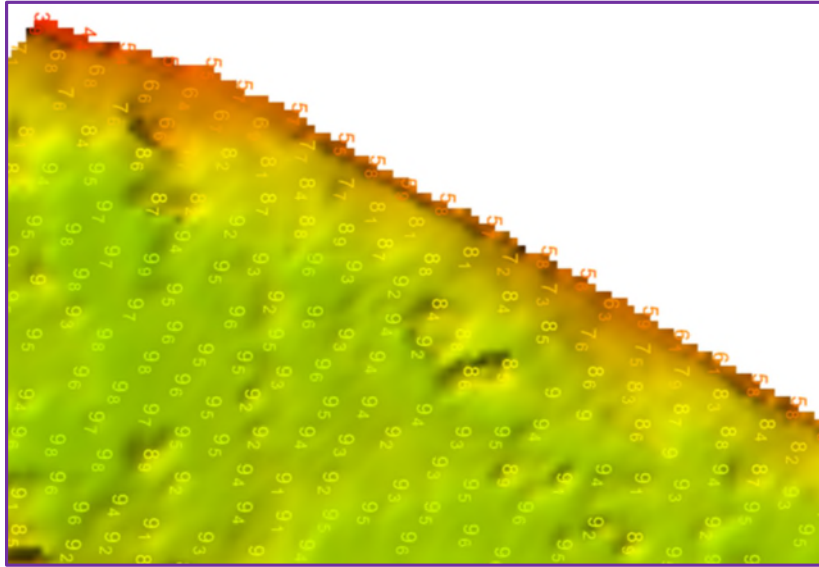
Please be advised that after review of the bathymetry from the CHS survey, the following are the recommended maximum drafts for Wharf 13.

Ships with an overall length (OAL) less than 150m:	no draft restriction, i.e. published Seaway maximum draft permitted
Ships with an OAL between 150m and 200m:	maximum draft of 8.0m
Ships with OAL greater than 200m:	maximum draft of 7.6m

The following drawing identifies locations of high spots along Wharf 13.

Please note that ship arrivals and departures from the wharf will be monitored closely and any change required to the maximum draft will be communicated promptly.

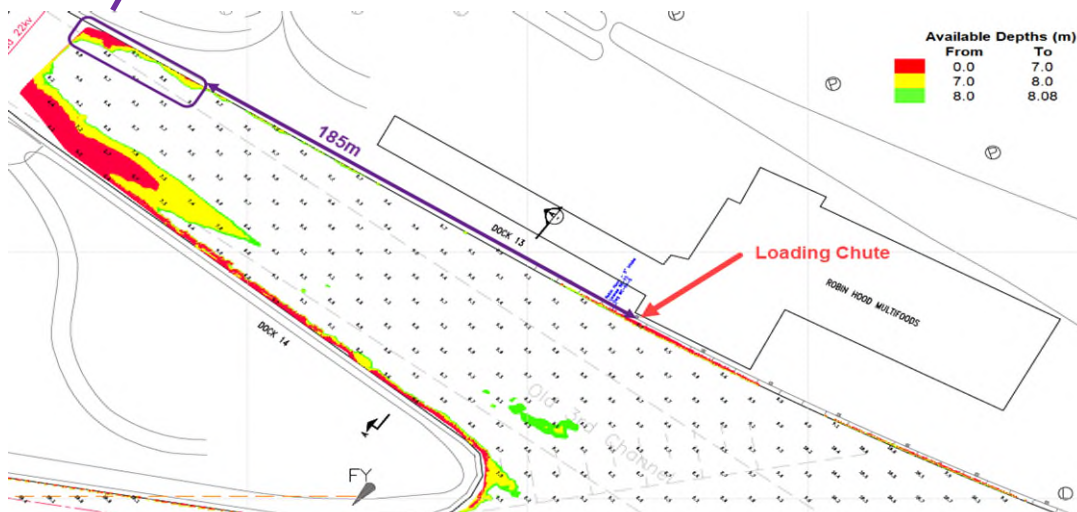
Bathymetry of area circled in purple
(185m from loading chute)
