2026 - NOTICE TO SHIPPING # 1

NIAGARA REGION WELLAND CANAL

General Instructions

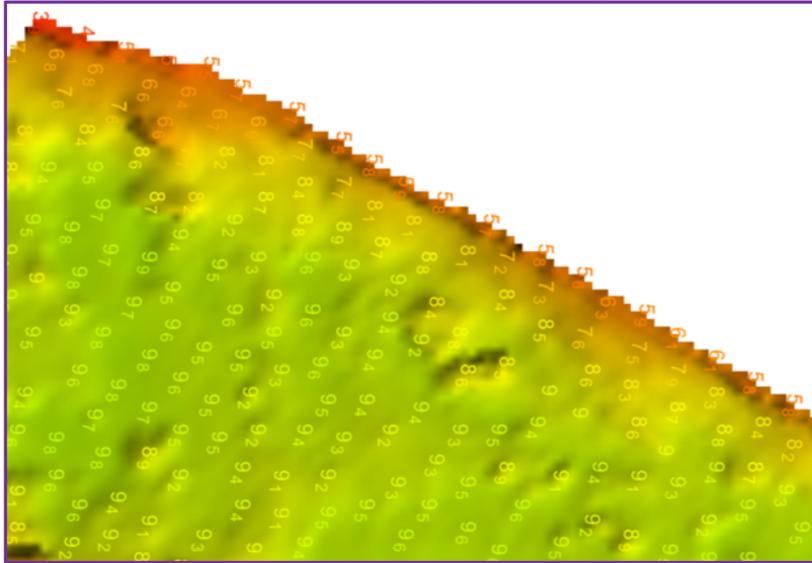
Please be advised that after review of the bathymetry from the CHS survey, the following are the recommended maximum drafts for Wharf 13.

Ships with an OAL 200m or less:	maximum draft of 8.00m
Ships with OAL greater than 200m:	maximum draft of 7.45m

The following drawing identifies locations of high spots along Wharf 13.

Please note that ship arrivals and departures from the wharf will be monitored closely and any change required to the maximum draft will be communicated promptly.

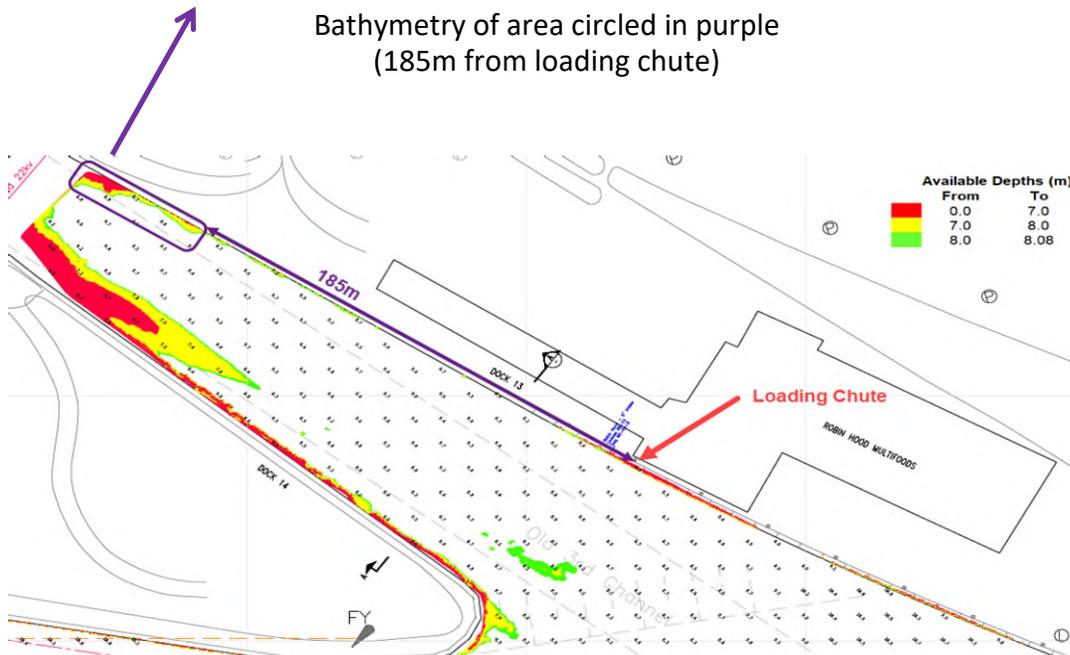
Bathymetry of area circled in purple
(185m from loading chute)
